BELZONA LEAD CHAPEL ROOF

Chapel roof at major university

Deteriorating lead roof required long-term protection.

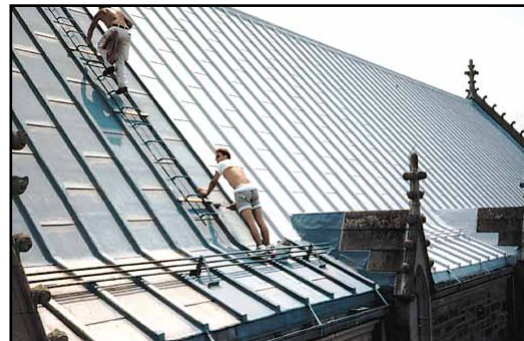
1. Belzona® 3111 applied to the right, Belzona® 3921 being applied at left, uncoated section lower left.
2. Work continues at the apex.
3. Front view of the chapel, lead roof protected.
