O-RING FIT RESTORED WITH BELZONA

Power Plant in North Texas.

Air compressor cooler waterbox.

Eroded O-Ring fit.

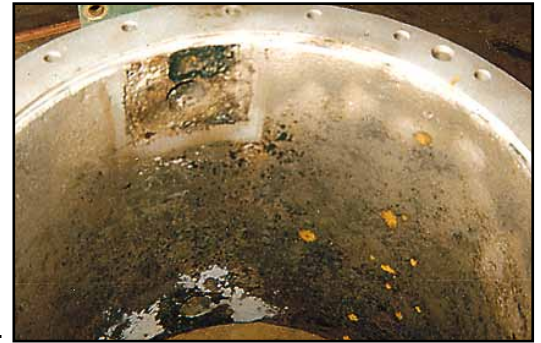
1. Corrosion and eroded o-ring fit.
2. A new O-Ring was used to form the fit.
3. Entire waterbox was coated.
4. O-Ring fit restored and back online.
