COOLING TOWER FAN BLADES REPAIRED WITH BELZONA

Refinery in Louisiana.

Fan blades of cooling tower - 14' long.

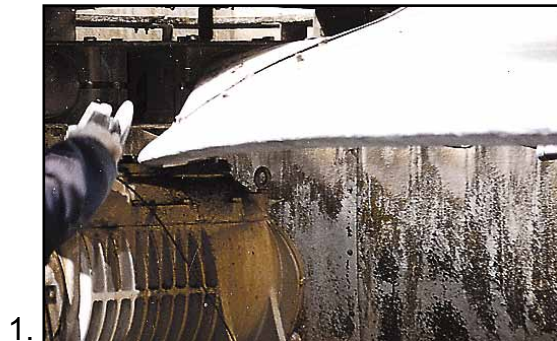
Light damage and erosion on the leading edge of the blades reduces the overall efficiency and operation of the cooling system.

1. Surface preparation by grinding.
2. Taping off for a neat repair.
3. Finished repair. Leading edge protected with Belzona.

The application was carried out in accordance with Belzona Know-How System Leaflet HEX-10.

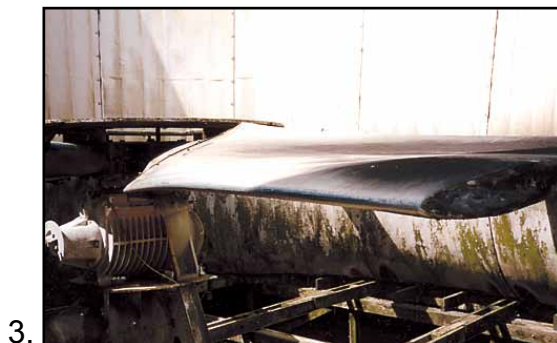
After 14 months, fiberglass blades on new units needed replacement at a cost of \$125,000. Over two years later the Belzona repair is in excellent condition. The plant has saved over \$200,000 in new blade replacement cost.
