## BELZONA PROTECTS EVAPORATOR TUBE SHEETS

Pulp and paper mill in British Columbia, Canada.

Evaporator tube sheet.

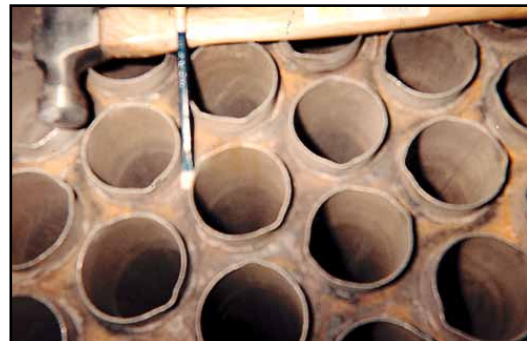
Erosion/corrosion of the tube sheet due to hot caustic (black liquor at 185°F) and galvanic corrosion due to dissimilar metals.

1. Inspection of previous coating shows degradation.
2. One year of Belzona® 1391 coating exhibits no signs of degradation.
3. Close-up view. Substrate is protected with Belzona® 1391.
