BELZONA MANWAY OPENING

Petroleum refinery in Texas.

Manway opening on chemical storage tank.

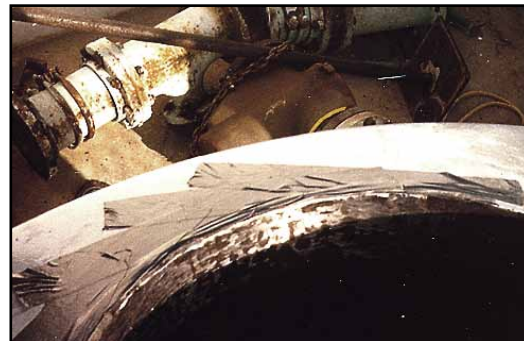
Opening on chemical tank was corroded to the point where a good seal was not possible.

1. Surface preparation performed with the repair area taped off.
2. Manway rebuilt.

The application was carried out in accordance with a modified version of Belzona Know-How System Leaflet TCC-10.
