BELZONA'S PROVEN PERFORMANCE IN SEPARATOR PROTECTION

Production Oil/Gas Separator

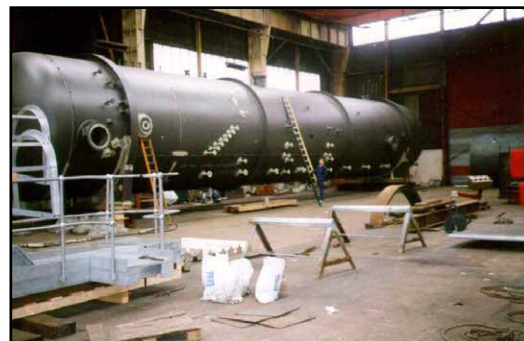
1. The vessel in the coating contractors workshop
2. Application underway
3. Coating inspection and repair being carried out
