## BELZONA PROVIDES LONG LASTING PIPE SUPPORTS

International Oil Company

Product and services pipelines at oil terminal. There are 5 separate pipelines of differing diameter.

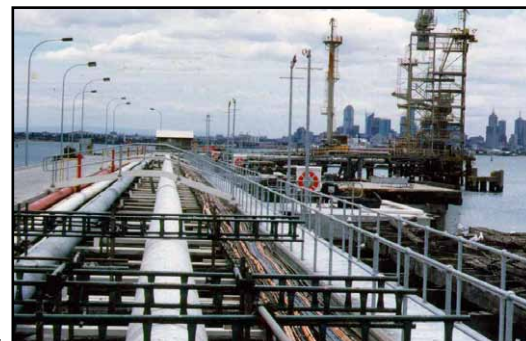
1. General view of terminal
2. Typical corroded state of original supports
3. New saddle bonded in place prior to re-painting of the pipe

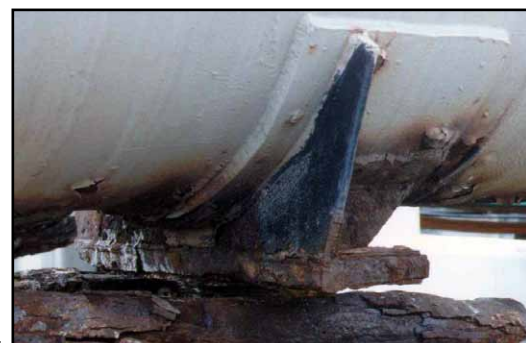
Severe corrosion of original pipe supports and pipe in way of support points.
