## BELZONA KEEPS BEET SLICER RUNNING

Sugar Beet Mill in North Dakota, U.S.A.

Beet slicer shaft

Bearing failure damaged beet slicer shaft

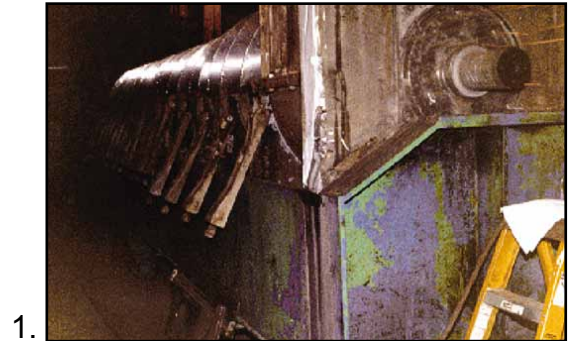
1. View of damaged shaft
2. Application of Belzona® 1111.
3. Use of a former to rebuild shaft.
4. Completely rebuilt shaft.
