## BELZONA SOLVES PROBLEM WITH AGITATOR BLADES

Sugar Beet Mill in Italy

Agitator in settling tank of wastewater treatment station in a sugar beet mill

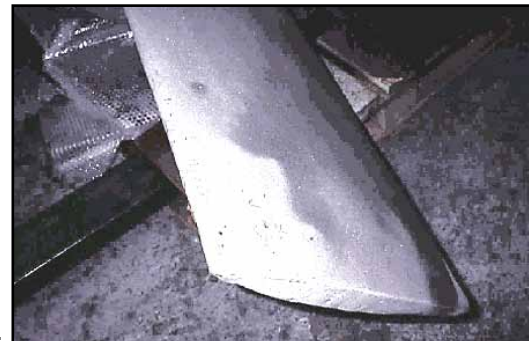
Abrasive solids in settling tank caused erosion on the surface of the agitator blades.

1. Damaged base of agitator.
2. Blades rebuilt with Belzona® 1000 Series product.
3. Application of Belzona® 2000 Series product.
