BELZONA PROVIDES SOLUTION TO WATER INJECTION PUMP

Sugar Cane Mill in Australia

Water injection pump

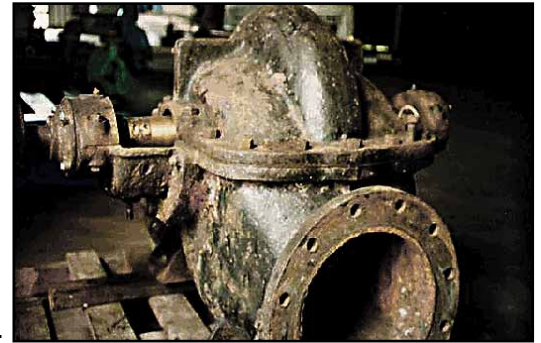
General erosion/corrosion on pump volute, wear ring seats and stuffing box

1. Split casing water injection pump.
2. Rebuilt wear ring seat and stuffing box.
3. Completely refurbished casing.
