## BELZONA REFURBISHES RUBBER-LINED PUMP

Sugar Cane Mill in Texas, U.S.A.

Ash slurry pump

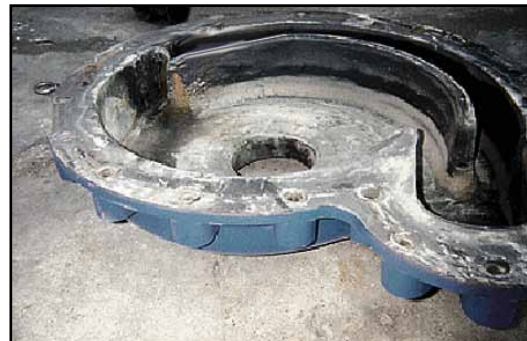
Pump casing and impeller suffer from erosion/corrosion due to the abrasive nature of the ash slurry.

1. View of uncoated casing.
2. Application of coating material to impeller.
3. Casing completely coated with Belzona® 2000 Series product.
