BELZONA TACKLES PROBLEM WITH MUD FILTER

Sugar Cane Mill in Australia

Faceplate of rotary valve on mud filter

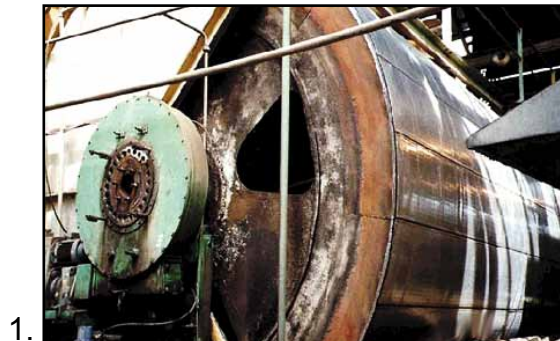
1. Mud filter.
2. Corroded faceplate of rotary valve
3. Forming technique being used to apply Belzona Ceramic Metal System
4. Completed application.

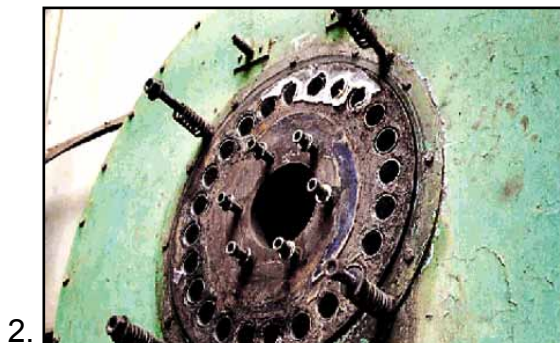
Corrosion on the faceplate of the rotary valve.

The application was carried out in accordance with a modified version of Belzona Know-How System Leaflet VPF-1.
