## BELZONA USED TO RESTORE CORRODED FLANGE ON CHIMNEY

Fertilizer manufacturer in France

An acid vapour evacuation unit installed on top of a high chimney

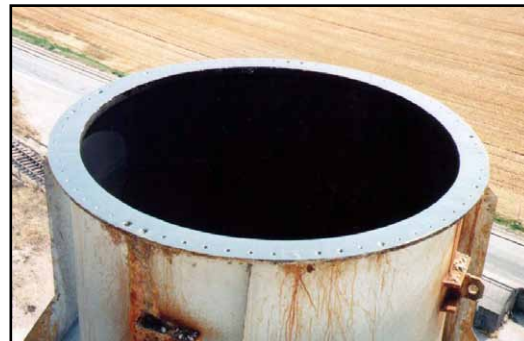
1. The difficult working situation on the chimney
2. The flange rebuilt and protected
3. Belzona® 2221 used to cast new gasket

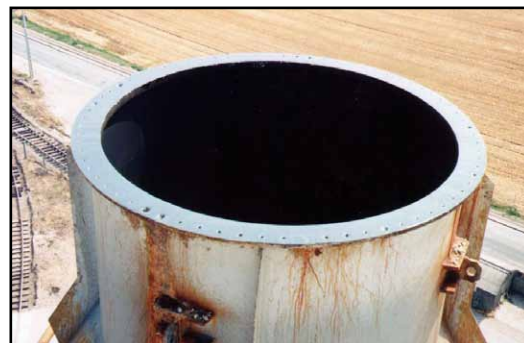
2.

The flange faces and the removable gasket had been attacked and corroded by the chemicals passing through the unit. In places the depth of corrosion on the flanges was 20-30 mm.

Ease of use was an important factor given the difficult working situation. The excellent chemical resistance of Belzona® 4311 has prevented further corrosion occurring on the flange.
