BELZONA® 1591 PROTECTS OIL/GAS SEPARATORS AT HIGH TEMPERATURE

Oil/Gas Test Separator designed to operate up to 150 °C.

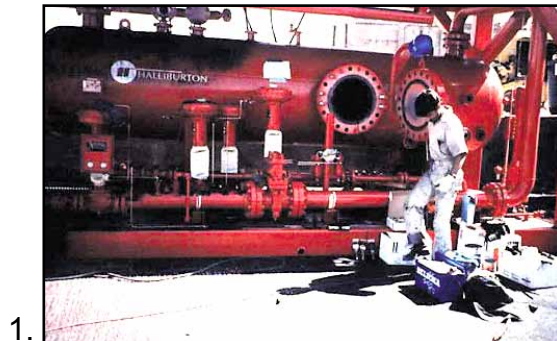
1. General view of separator.
2. Work underway applying Belzona® 1591.
3. Final inspection being carried out.
