BELZONA® 1591 PROTECTING COALESCER VESSEL

Coalescer vessel for installation on a Floating Oil Production and Storage vessel (an FPSO) destined for the North Sea.

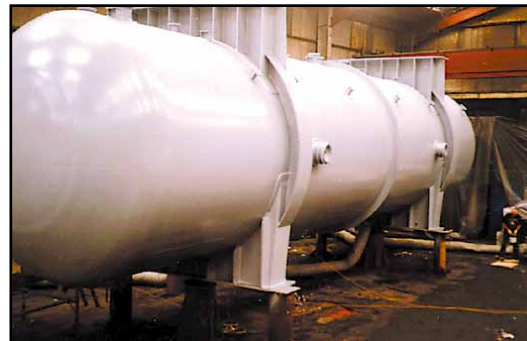
1. The Coalescer vessel.
2. Application underway inside.
3. The lower 1/3rd was protected.
