## BELZONA PRE-STRESSED CONCRETE BEAMS

Scale Beams of the refinery truck scale, originally installed in the 1970s.

Concrete severely eroded over time.

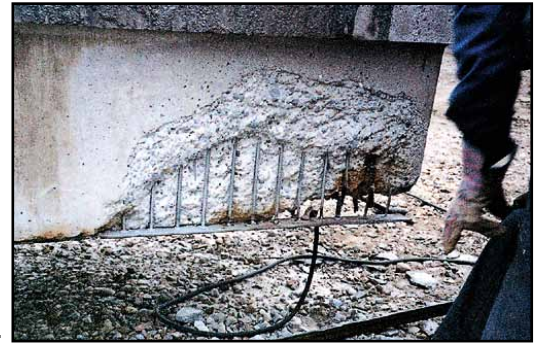
1. Area of worst damage, re-bar and bottom metal spine being repaired.
2. Application in progress. Note the polyethylene covered plywood being used as a former.
3. Completed repair.

Application was carried out in accordance with a modified version of Belzona Know-How System Leaflet TCC-9.
