BELZONA ANGLE IRON BONDED INTO PLACE

Oil Refinery in Canada

Scale beams of the refinery truck scale, originally installed in the 1970s.

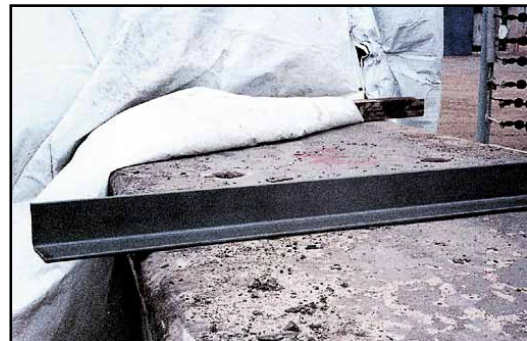
Concrete severely eroded. Exit end of concrete beam damaged by the impact of the scale bumping into the end of the scale sump wall.

1. Piece of 4 x 41/4 inch angle iron is prepared to be bonded into place.
2. Substrate conditioned with Belzona® 4911 (Magma TX Conditioner).
3. Angle iron strongly bonded into place with Belzona® 4111 (Magma- Quartz).
