BELZONA SEALS SF₆ LEAK IN HYDROELECTRIC POWER STATION

Hydroelectric power generating station in British Columbia, Canada

Flanges of SF₆ (sulfur hexafluoride) buss bars.

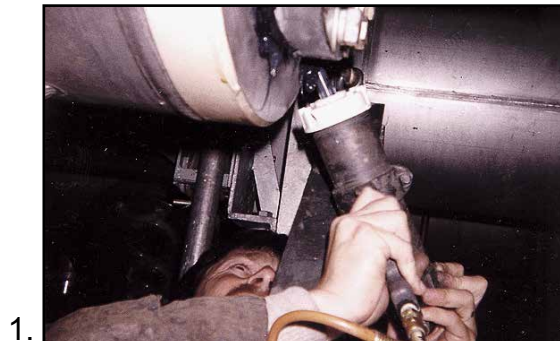
The SF₆ dielectric gaseous insulator was leaking from the flange.

1. Belzona® 2211 (MP Hi-Build Elastomer) was injected between flanges to fill the gap.
2. Completed application.
3. Various leaking flanges were sealed

The application was carried out in accordance with Belzona Know-How System Leaflet GSS-4.
