## BELZONA IN-SITU REBUILD OF DECK WINCH

Liquefied Natural Gas Carrier, France

Shaft of deck winch

Wear on shaft in way of cable drum

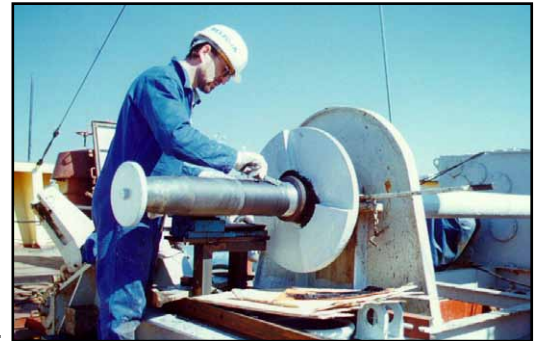
1. Belzona® 1131 being applied to the prepared shaft
2. In-situ machining of the Belzona® 1131 being carried out
3. The completed application

Application was carried out in accordance with Belzona Know-How System Leaflet MPT-1. Portable lathe was used to machine shaft in place without removing or complete dismantling.
