BELZONA RENOVATES DILAPIDATED WATER TOWER

120 foot tall concrete water tower

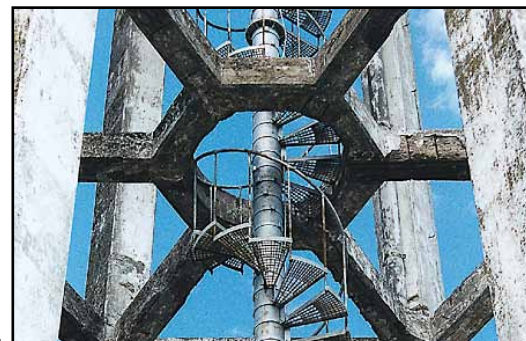
The concrete support structure and water tank was deteriorated. Pieces of concrete were falling off exposing passersby to injury.

1. Severe damage to the tower.
2. Deterioration of the concrete structures.
3. Application of Belzona® 4141.
4. The finished repair.
