BELZONA SOLVES DREDGE PUMP WOES

Marine contractor, Panama City, Florida, U.S.A.

Dredge pump repair.

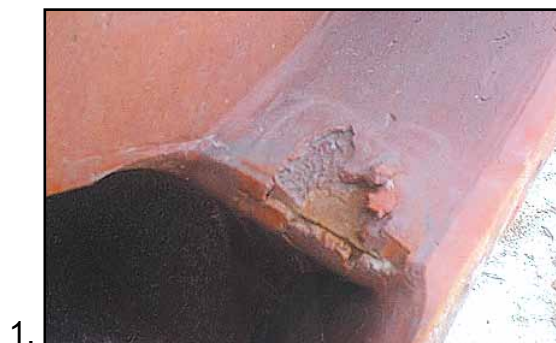
Large roots and stones damaged cutwater and stripped rubber coating from pump.

1. The damage.
2. Completed repair.
3. Dredge pump ready for service.
