BELZONA KEEPS HEAVY MACHINERY ON TRACK

Sawmill in Northern California

Repair wallowed track rail and pads

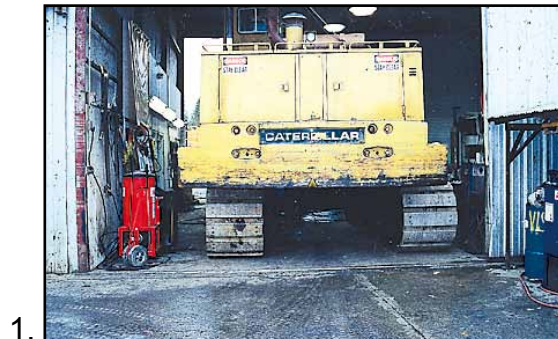
1. Cat 245 grapple .
2. Rail surface preparation.
3. Work in progress.
4. Finished product.
