## BELZONA RESTORES PERFORATED PROFILE OF COUCH ROLL

Paper Mill in Quebec, Canada

A hollow perforated Couch Roll containing one or two stationary high-vacuum suction boxes for de-watering the sheet.

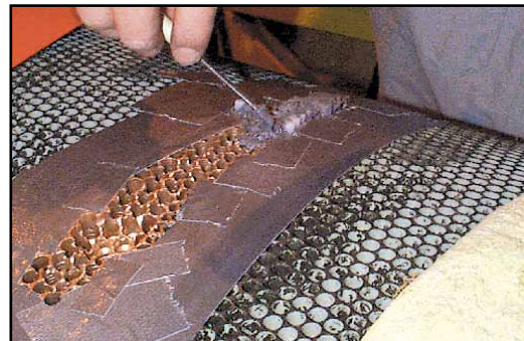
A mill wright's tool was introduced onto the couch roll and caused damage to a foot long section of the roll.

1. Rebuilding the foot long damage area with Belzona® 1111.
2. Inserting the tapered nylon plugs.
3. Grinding the plugs as well as the Belzona® 1111 flush with the roll.
4. Finished repair with the roll profile restored.
