## BELZONA LAP JOINT REPAIR AT SAWMILL

Sawmill in Ontario, Canada

Conveyor belt that transfers pieces of veneer to the chipper.

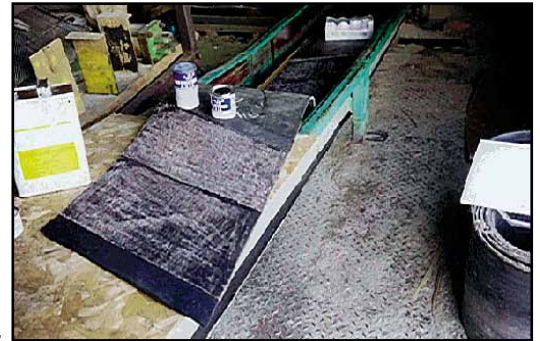
1. Delaminated lap joint being prepared for the Belzona application.
2. Both halves of the belt were coated with Belzona® 2111.
3. The lap joint bonded together for a long lasting, durable, in-place repair.
