BELZONA REPAIR TO TURBO-PULPER

UK Paper Mill

Stainless steel sealing ring inside Turbo-pulper.

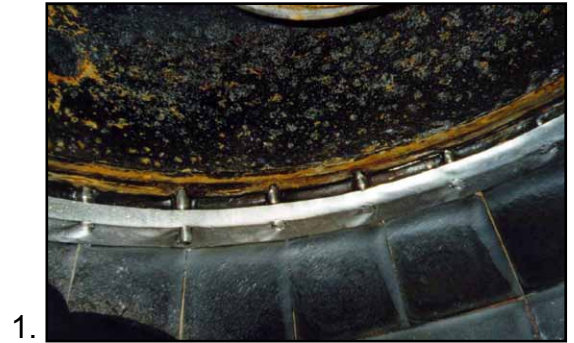
Erosion from pulp had worn away the sealing ring exposing the Stainless steel bolts.

1. The degree of erosion on the sealing ring and bolts clearly evident.
2. Application underway inside the pulper.
3. Sealing ring and bolts completely encapsulated with Belzona® 1111
