REFORMING OF TRANSOM FLANGE WITH BELZONA

Jet thrust propulsion system on High speed ferry operating between UK and Ireland

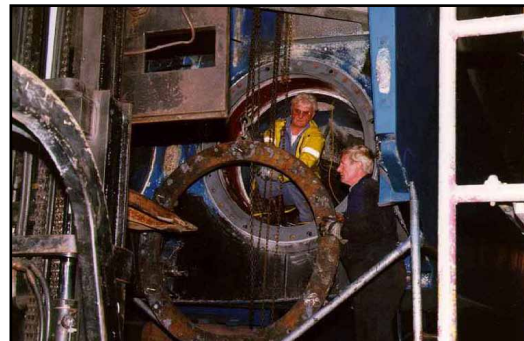
1. The forming ring being positioned.
2. Injection of Belzona® 1321 underway
3. The perfectly formed flange face awaiting removal of corks.
4. The jet bowl waiting to be installed.
