PROTECTION OF BOILER FEED PUMPS WITH BELZONA® 1391

Chemical plant - Poland

6 stage boiler feed pumps operating at 105°C (220°F) and 50 bar pressure at 2950 rpm.

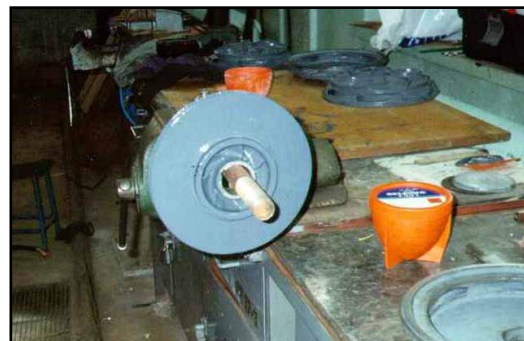
Erosion on the impellers and casing.

1. Application underway on one of the impellers.
2. Application complete.
3. Pump in service

Belzona® 1391 (Ceramic HT Metal)

Application carried out in accordance with Belzona Know-How System Leaflet CEP-3.

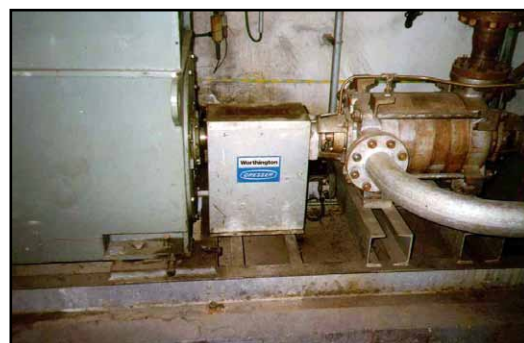
3.

A total of 5 pumps have now been coated and original pump is still performing satisfactory after 4 years in service.
