## BELZONA PROTECTION ON RIVER BARRAGE

Flood defence barrage on tidal river

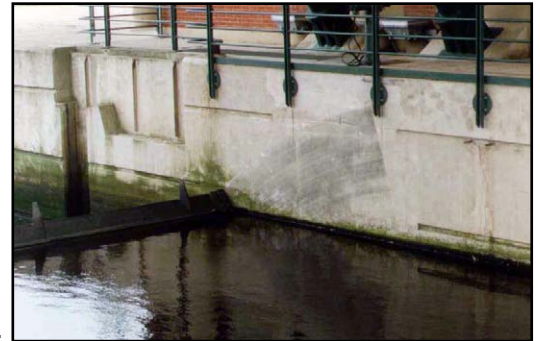
The rubber seals on the moving gates were being damaged by the concrete walls when the barrage was raised and lowered.

1. The abrasion from the rubber seals clearly evident on the concrete
2. The completed application
3. The barrage in action
