BELZONA HEATING PIPE FITTINGS ABOARD SUPERTANKER

A 600 foot supertanker barge at Tampa Bay, Florida, U.S.A.

January 1997

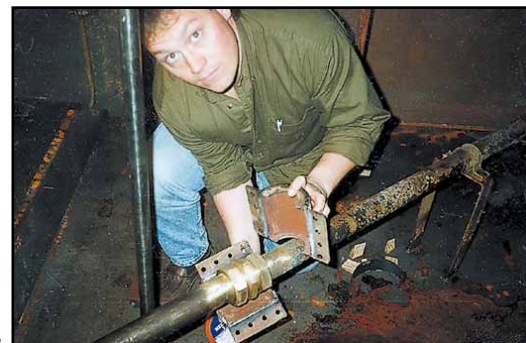
1. Following surface preparation, a collar was used.
2. Application of product.
3. Pipe fittings and sea dogs are happy with the repair.
