BELZONA LEAK SEALING ON VALVES

Emergency water valves, 1.6m and 2.2m diameter, in dam

Erosion-corrosion leading to water leakage

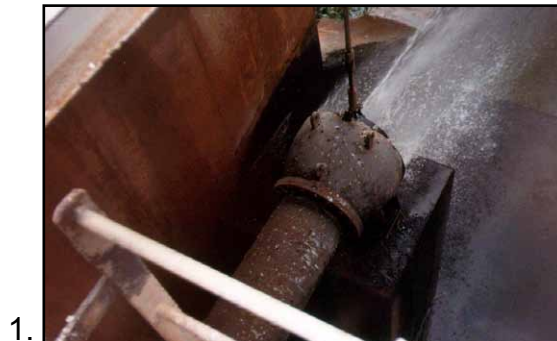
1. The degree of water leakage clearly evident from the 1.6m valve
2. Work underway on the 2.2m valve
3. Application completed
4. The two valves re-installed at the dam base
