## BELZONA STOPS DAMAGE FROM PITTED CHOCKS

Oil tanker, Pacific Northwest, U.S.A.

Pitted chocks

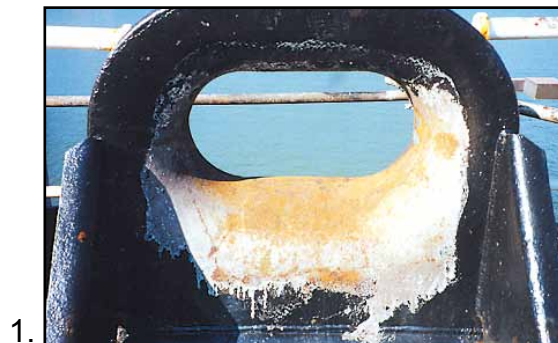
1. Close-up of chock with peeling paint.
2. View of chock showing extensive pitting.
3. Surface preparation in progress.
4. Finished application.

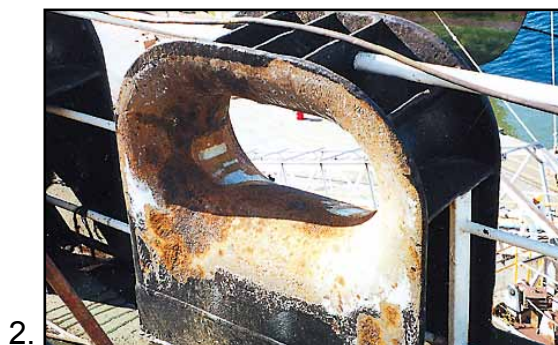
Ship's mooring lines (hawsers) are very expensive. The steel casting for the chocks became pitted from the salt. This caused jagged edges which wore out the hawsers prematurely.
