BELZONA RESTORES COAL BOXES

A University's coal fired power plant in Western Massachusetts, U.S.A.

Coal handling boxes.

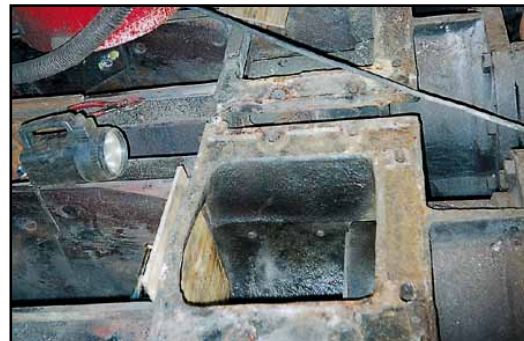
1. View of surface preparation of the six coal boxes.
2. Close-up of wear areas.
3. Completed Belzona® 1811 repair.

The application was carried out in accordance with a modified version of Belzona Know-How System Leaflets SHM-13 and -14.

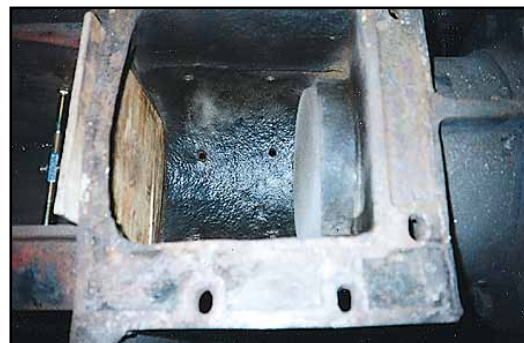
Coal boxes were worn from years of abrasion.

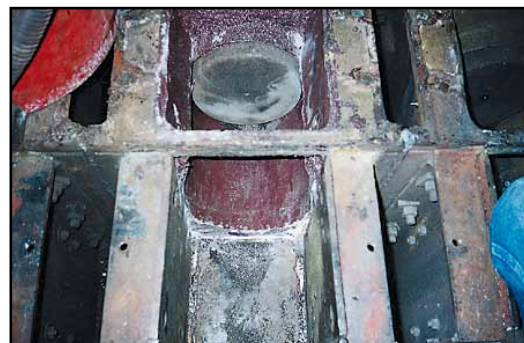
The cost for replacing all six (6) coal boxes would have been \$21,000 plus additional installation costs. The Belzona repairs were carried out for approximately \$2,500. A one year inspection shows no signs of wear.

Belzona® 1811 (Ceramic Carbide)
