DUCT SEALING WITH BELZONA® 4211

Telecommunications in India

Underground chambers containing cable joints

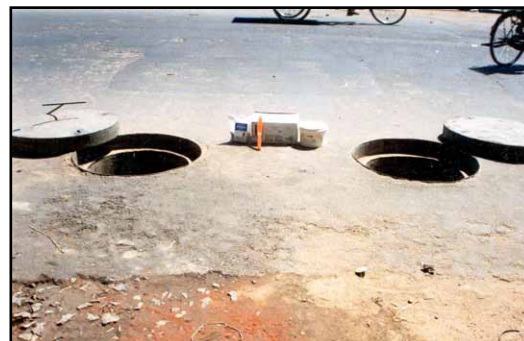
1. Access to the chambers
2. The cable connections
3. & 4. Application of Belzona® 4211 underway
