BELZONA FOUR YEARS ON COAL PIPES

Coal fired power plant in Alabama, U.S.A.

Fuel lines carry coal from the pulverizer

Coal piping is worn from years of abrasion.

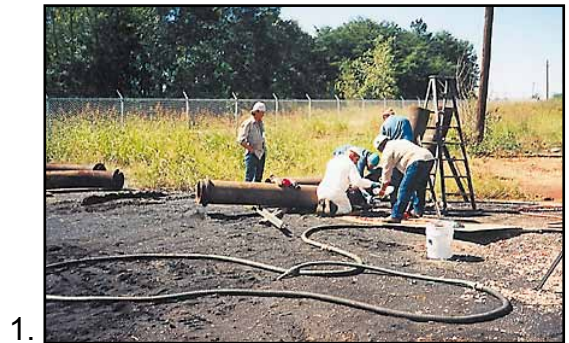
1. Grit blasting was used for surface preparation.
2. Windows were cut to gain access to worn areas.
3. Application of product.
