BELZONA® 1391 PROTECTS CATALYTIC CRACKER

Oil Refinery, U.K.

The light ends tower within the Catalytic Cracker

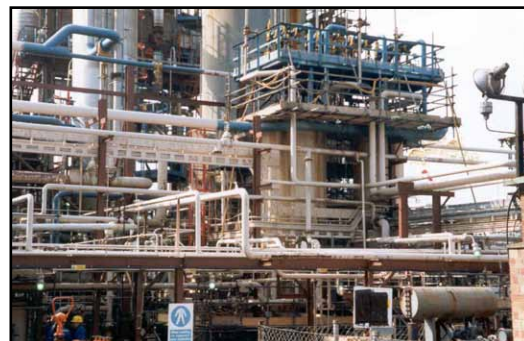
1. General view of the application site
2. Application of Belzona® 1391 underway
3. View through the manway showing confined working conditions
4. Application completed with hatch covers also coated with Belzona® 1391
