BELZONA MENDS HOLE FROM ASH DUST

Coal fired power plant in Alabama, U.S.A.

Fan housing

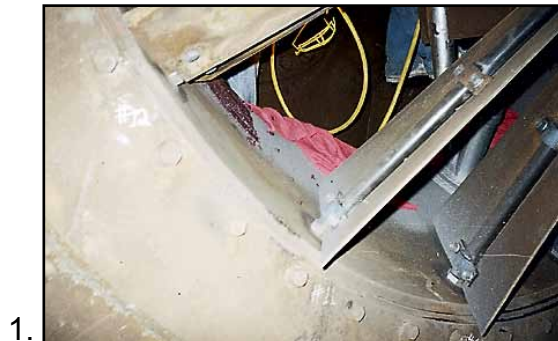
1. Work commenced at night.
2. The hole is mended with Belzona® 1811.
3. Close-up view of the repaired area.

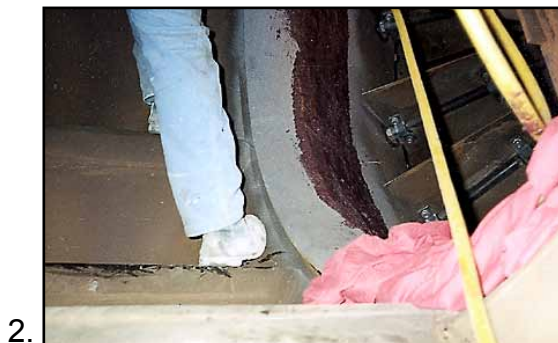
Hole worn through metal caused by abrasive ash dust.

Application was carried out in accordance with Belzona Know-How System Leaflets FBC-4 and FBC-5.
