BELZONA REFORMS MAIN ENGINE LINER LANDS AND CORRODED COOLING WATER PASSAGES

Cylinder block of main engine.

Corrosion in water cooled top land area of engine block.

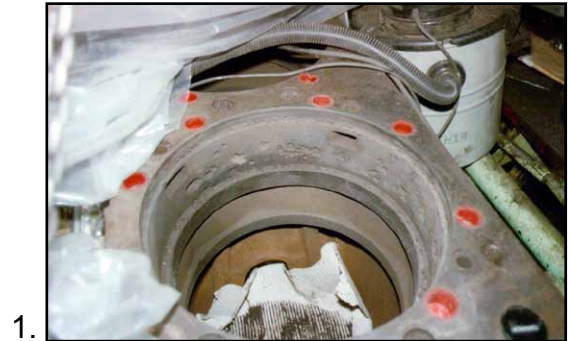
1. After grit blasting the degree of corrosion clearly evident
2. Lower land reformed
3. Cylinder rebuilt awaiting final finishing.

Application was carried out in accordance with Belzona Know-How System Leaflet ENC-4, using formers to reconstruct the two cylinder liner lands in each cylinder.
