BELZONA REPAIR AND PROTECTION OF STABILISER SHAFT

Stabiliser shaft

Severe pitting corrosion in-board of bearing

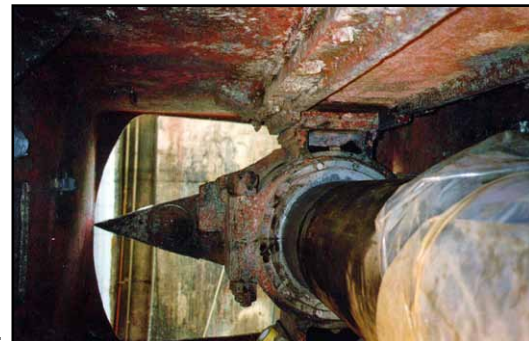
1. General view of the stabiliser shaft
2. After grit blasting, degree of erosion-corrosion damage clearly evident
3. Application of Belzona® 1111 being completed
