BELZONA REBUILD OF CORRODED RUDDER STOCK

Merchant vessel, France

Junction of stainless steel liner on rudder stock

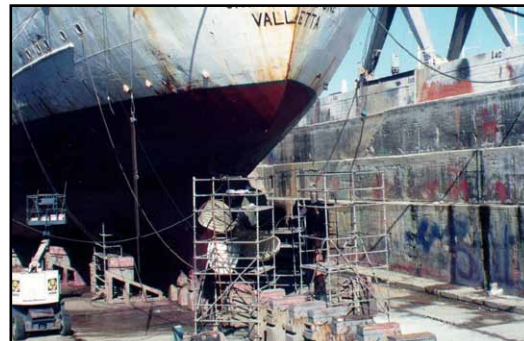
1. Work underway on the vessel in dry-dock
2. The seal face of the liner was masked before grit blasting
3. Completed application
