BELZONA® 4131 REPAIRS TO SPALLED CONCRETE

Canopy over a busy shopping area

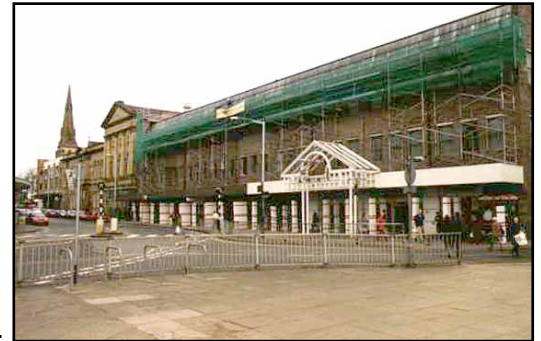
1. General view of the site with specially boarded up Acrows insisted on by safety officials.
2. The degree of concrete damage clearly evident.
3. Rebuilding complete and gutter re-instated.

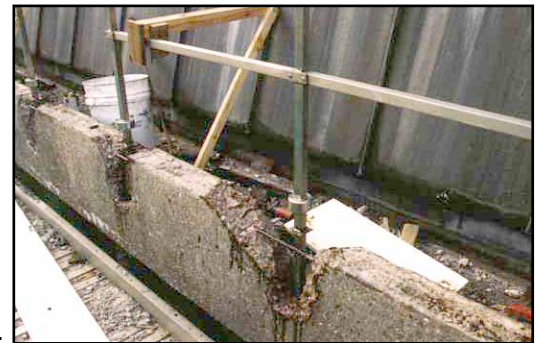
2.

Extensive spalling had made using the hand-rail unsafe.

When work initially started damage was found to be more extensive than originally thought. Old railings were replaced. Rapid repairs with Belzona® 4131 ensured minimum disruption.
