## BELZONA REPAIRS TO STEEL ROLLING MILL

Steel mill

Load block area on sides of mill (4 per mill)

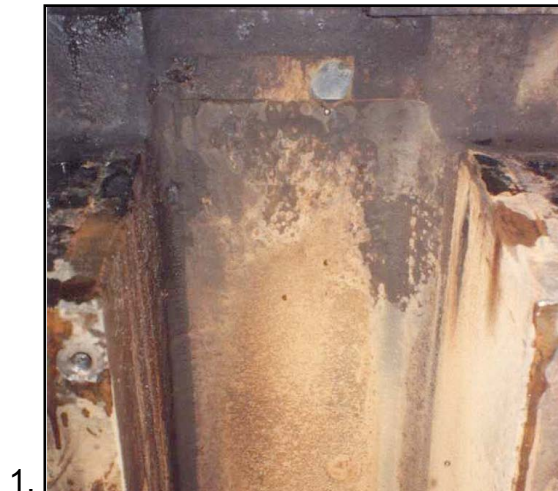
Corrosion caused by cooling water between mill housing and load block. Increased clearance leads to loss of pre-tension on holding bolts.

1. Corrosion evident after grit blasting.
2. Moulds being positioned.
3. Surfaces reformed with Belzona.
