BELZONA® 6111 PROTECTION OF FIRE HYDRANTS

Municipality

External surfaces of fire hydrants

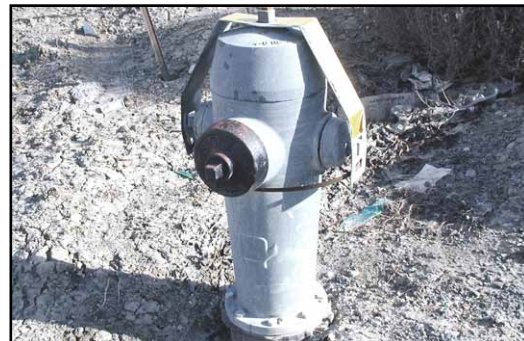
1. Hydrant with Belzona® 6111 applied.
2. Completed application with top coat of paint applied.

Application carried out in accordance with a modified version of Belzona Know-How System Leaflet TCC-5, before overpainting with required color top coat.
