BELZONA REFURBISHES SCRUBBER RUBBER

TVA Powerplant (Tennessee Valley Authority- U.S.A.)

July 2000

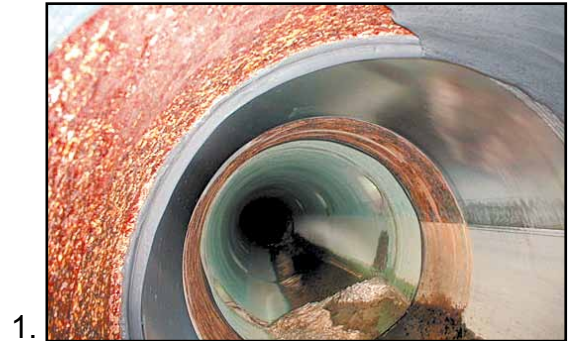
Rubber lining on a scrubber unit was worn away leaving carbon steel exposed.

1. Application begins.
2. Application continues
3. Close-up view at a repaired area.

The application was carried out in accordance with a modified version of Belzona Know-How System Leaflets SHM-8 and -9.
