A LEAK SEALING SOLUTION WITH BELZONA

Chemical plant

Stainless steel absorber vessel and agitator

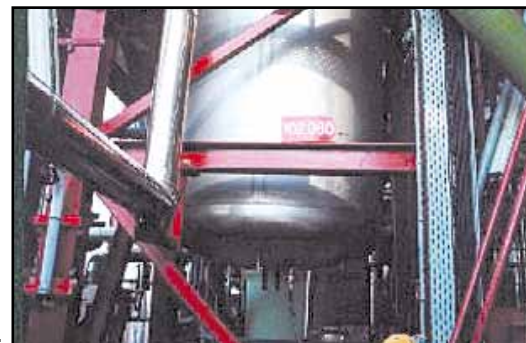
Leaks from chemical attack and galvanic corrosion. Chemicals included 30% concentrated sodium hydroxide, 65% concentrated sulphuric acid and 30% concentrated hydrochloric acid.

1. Stainless steel absorber vessel and agitator - general view .
2. Applying Belzona® 1111 to problem areas.
3. Applying Belzona® 4341.
4. Protected agitator ready for service.
