BELZONA PROTECTS WELD SEAMS IN RECYCLING DRUM

Papermill in the Netherlands

Recycling drum used to process waste paper for use in newspaper.

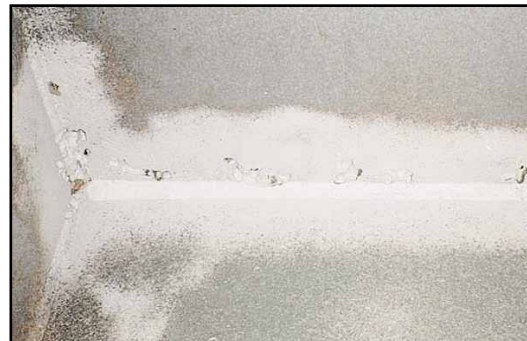
The debris settles in the 90 degree angles of the weld seams. The 60°C (140°F) environment with a pH 10 leads to galvanic and crevice corrosion of the weld seams.

1. Weld seams after grit blasting.
2. Work in progress applying Belzona in the drum.
3. Some of the completed repairs.

The application was carried out in accordance with Belzona Know-How System Leaflet TCC-5.

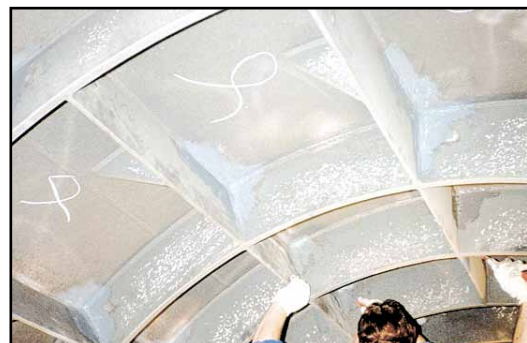
3.

The Belzona repair was inspected in April 2000 and there were no signs of wear, breakdown or further corrosion.
