BELZONA® 3111 PROVEN PERFORMANCE

Chemical plant in the United Kingdom

Roof areas over offices and workshops.

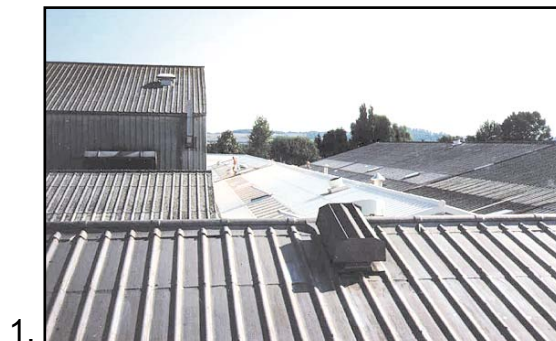
Severe water penetration, particularly through joints, seams, glazing units and gutters.

1. Work underway on the workshop roof.
2. Horizontal area of office roof undergoing treatment.
3. Completed application.

Belzona® 3111 (Flexible Membrane)

The application was carried out in accordance with Belzona Know-How System Leaflets RPA-1, -3 and -6.

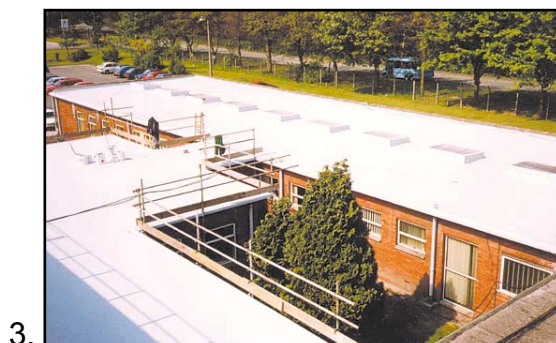
Belzona was chosen over other materials as previous repairs with competitive materials on the site had underperformed. Belzona system lived up to expectations and was in excellent condition when inspected in 1997.
