BELZONA SAVES REPLACEMENT COSTS

Quarry in Germany

Universal joint between power unit and trailer of articulated earth mover.

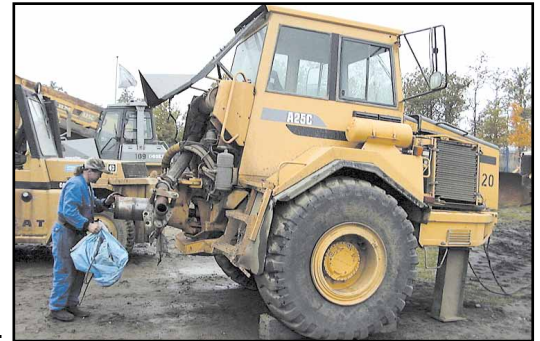
1. The power unit.
2. The damaged shaft.
3. Application of the Belzona® 1111 underway.
4. The completed repair.

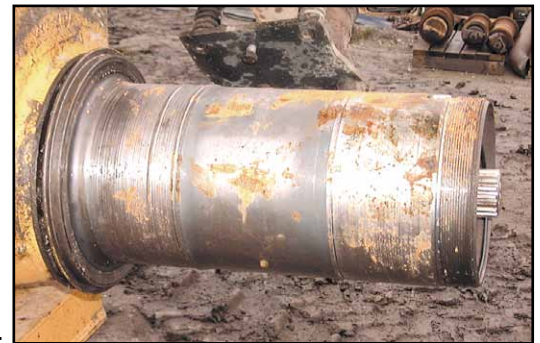
2.

The ends of the shaft were worn due to play in the joint.
