## BELZONA PROTECTS HYDROELECTRIC TURBINE RUNNER

Hydroelectric power plant in Scotland

Francis turbine runner

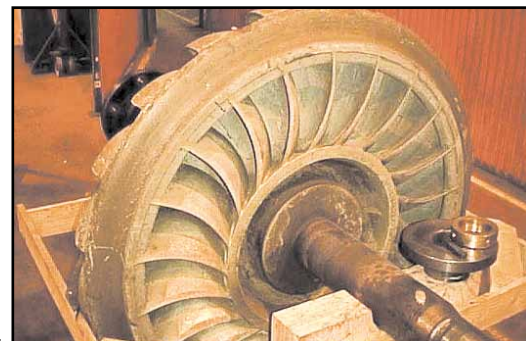
Over 40 years of service led to cavitation and corrosion.

1. The runner prior to application.
2. Application underway with second coat of Belzona® 1341 being applied.
3. The completed application with the smoothness of Belzona® 1341 clearly evident.
