BELZONA PROTECTS HYDROELECTRIC TURBINE CASING

Hydroelectric power plant in Japan

Spiral casing of large Francis turbine

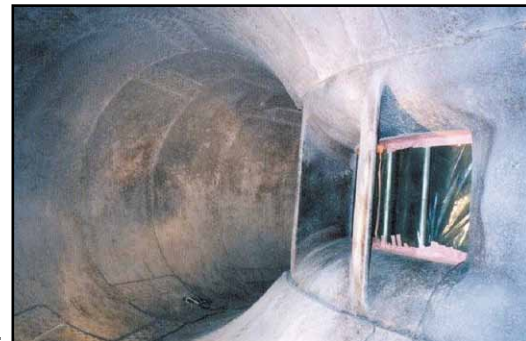
1. The casing after grit blasting.
2. The casing after application of Belzona® 1341.
3. The scale of the application is clearly evident.

The application was carried out in accordance with Belzona Know-How System Leaflet CEP-10. The Belzona® 1341 was applied by airless spray to speed application on the large areas involved.
