BELZONA KEEPS WORN HOSE WORKING

Shipping company in Canada

Worn rubber hose

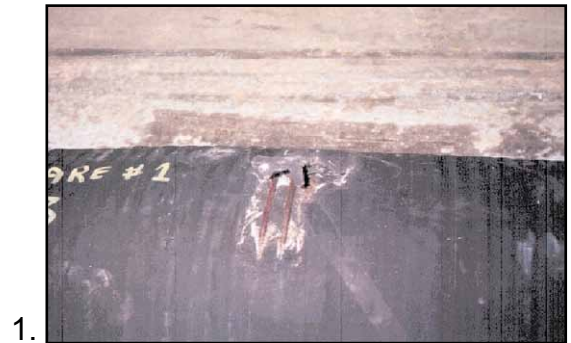
The unloading cement hose had worn through to the reinforcement wire.

1. Overview of damaged area.
2. Loose pieces have been removed.
3. The conditioner, reinforcement sheet and Belzona® 2311 have been used to fill area.
4. The finished repair.
